**NPG Report No. 1535**

**DIRECT CONTACT EXPLOSION EFFECTS ON  
ORDNANCE MATERIALS - TESTS ON MILD STEEL, STS ARMOR AND  
2024-T4 ALUMINUM ALLOY PLATES 1-1/2 INCHES THICK**

**Date: 29 APRIL 1957**

Foundational Research Project  
NPG-T-1801-4

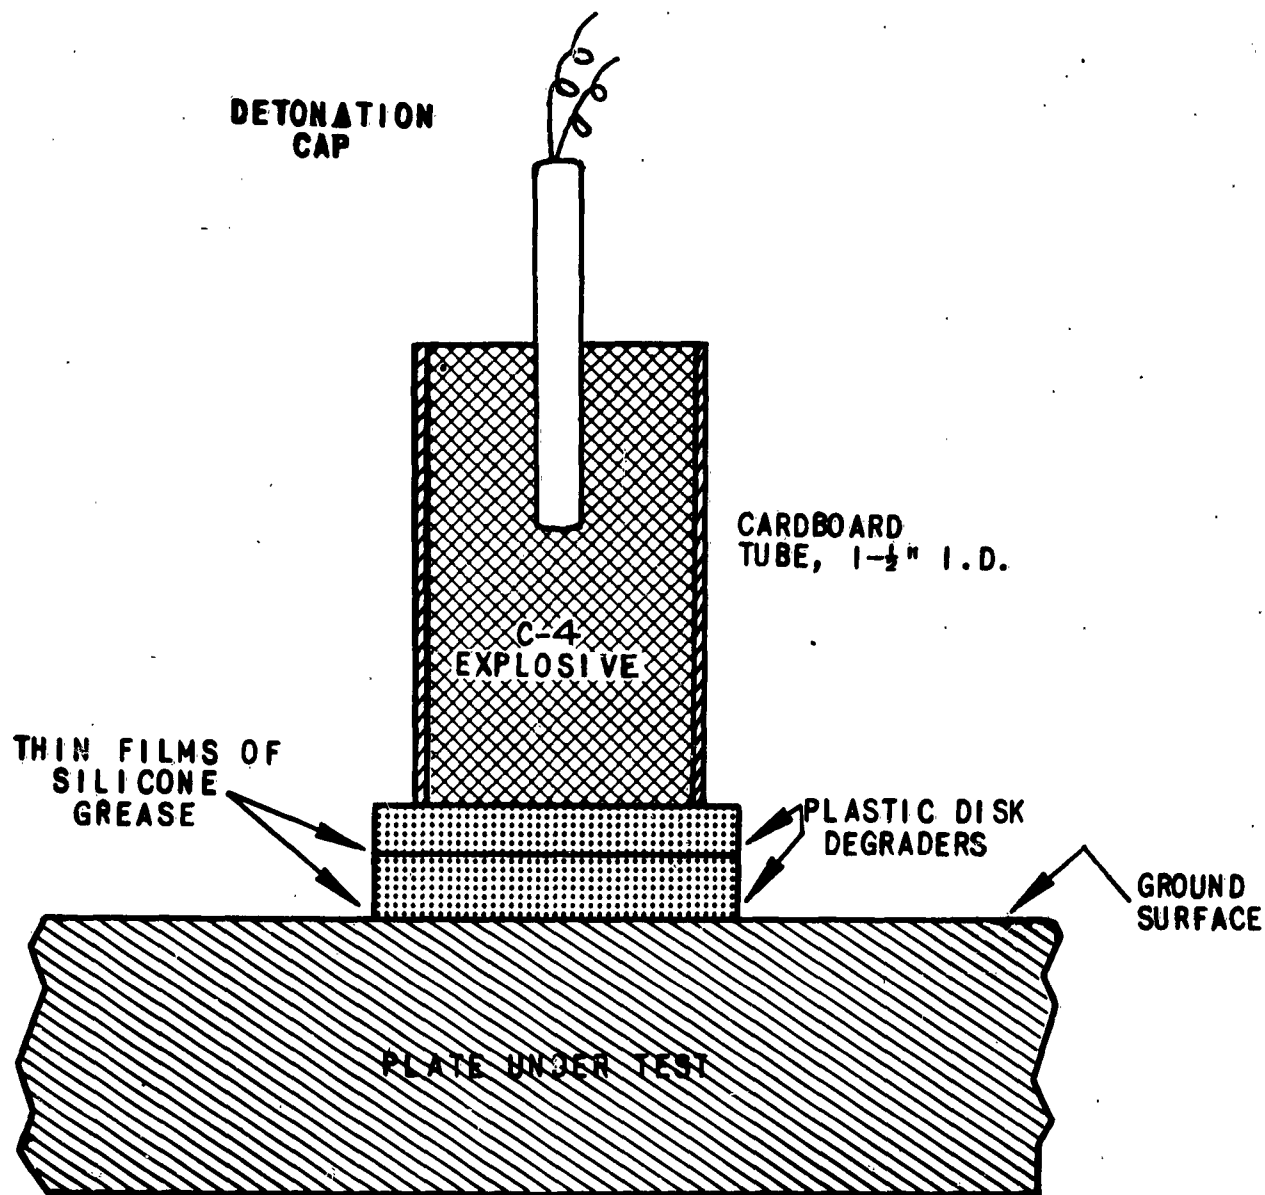
Figure 1

SECTION THROUGH CLOSE CONTACT  
EXPLOSIVE TEST FOR INTERNAL  
SEPARATION OF ARMOR PLATE

The method of applying a shock impulse is illustrated in Figure 1. The explosive candle was a cardboard tube container packed with 0.27 pound of composition C-4 plastic high explosive, using care to produce uniformity in a series of charges.

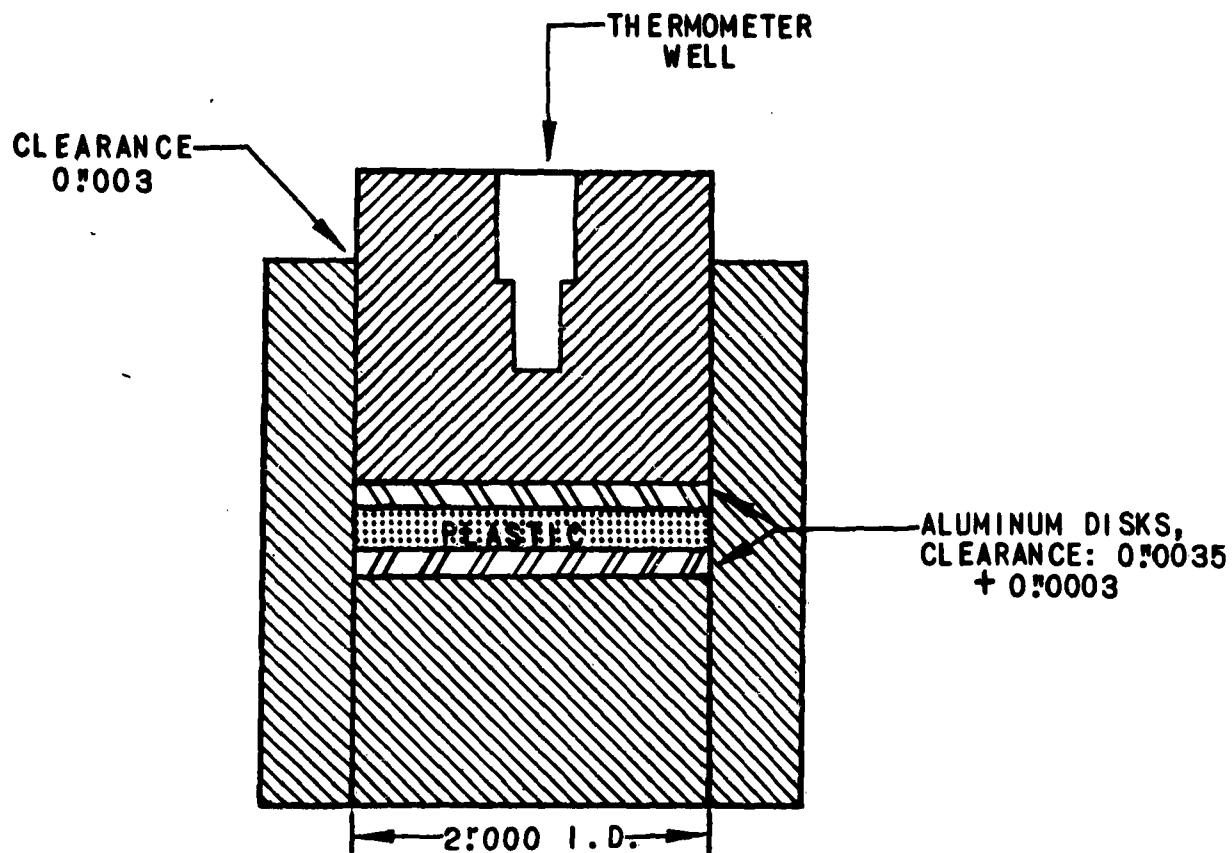
# SECTIONAL VIEW OF MOLD FOR MAKING PRECISION PLASTIC DISK DEGRADERS

Plastic Cavity Sealed by Differential  
Expansion of Aluminum Disks.

A critical feature of the test is the preparation of precision-molded plastic disk degraders of variable thickness and a high degree of surface flatness. The mold design shown in Figure 2 was based on an English technique for pressing flat disks described in reference (f).

"At room temperature the diameter of the aluminum disks is slightly less than the internal diameter of the cylinder but due to aluminum having a larger coefficient of expansion than steel, the aluminum disk diameter is slightly greater at the molding temperature, about 250°C. The aluminum disks therefore act as a seal preventing the material exuding into the annular gap between the piston and cylinder while the material is molded.... The disks, with the specimen sandwiched between them, are easily removed from the cold mold and are then sheared off the specimen."

The tight seal enabled close control of disk thickness by weighing the charge of molding compound. The two-inch diameter disks ranged from 1/8 to 5/8 inch in thickness; larger standoffs were obtained by stacking. The molding compound was medium flow Tenite acetate (Tenite I) designated 036A-29873-M, clear transparent. A trial lot was supplied gratis for development work by Eastman Chemical Products, Inc., Kingsport, Tennessee. The hardness of the molded plastic was approximately 75 Rockwell R. After light rubbing on fine emery paper, the disks were flat

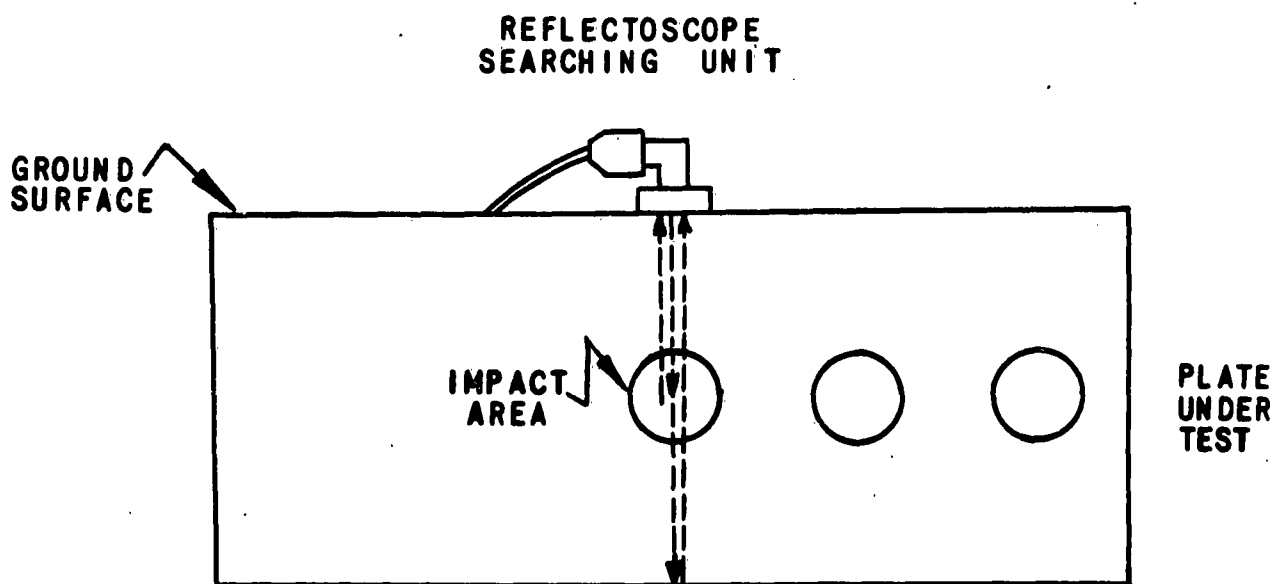
FIGURE 3

ULTRASONIC REFLECTOSCOPE EXAMINATION  
FOR INITIATION OF INTERNAL FRACTURE

A test series was started with a close standoff which allowed a substantial bulge to form on the back of the plate. Subsequent impacts were made at increasing standoffs and the bulge gradually disappeared. From then on the impacted zone was inspected ultrasonically after each explosion. A Sperry type UR reflectoscope was used as shown in Figure 3. Part of the ultrasonic energy was reflected from the internally damaged zone behind an impact and appeared as "pips" on the reflectoscope screen, Figure 4. Reduction in pip height was gradual as plastic standoff increased until only small remaining pips suggested that internal fracture had ceased. The worked metal without fracture produced some reflection. A series was concluded when it was believed that standoff had been increased to a thickness sufficient to prevent internal cracks. All tests were made at ambient temperature.

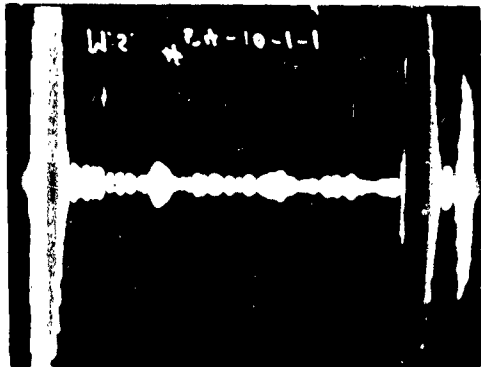
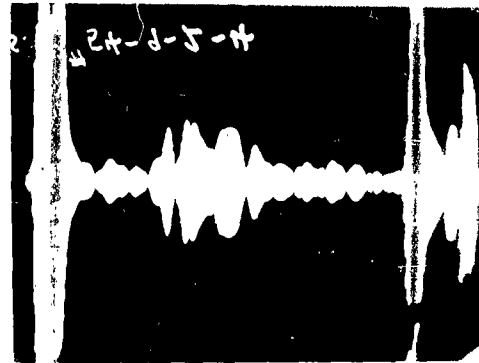
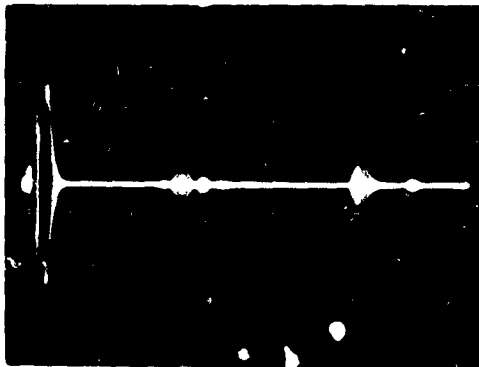
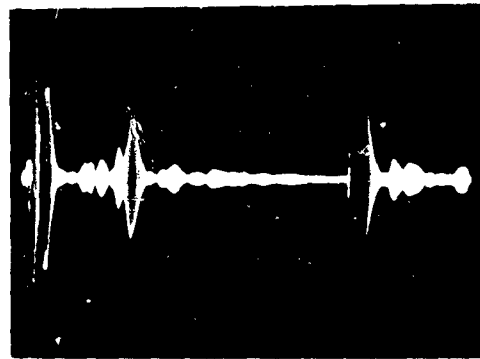
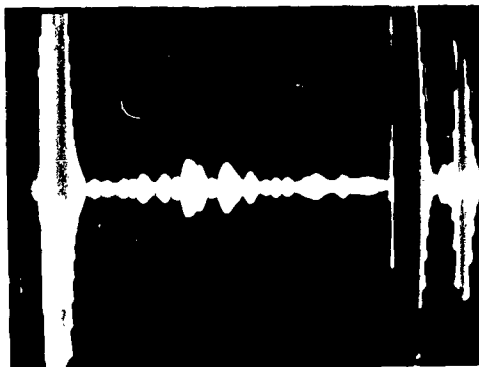
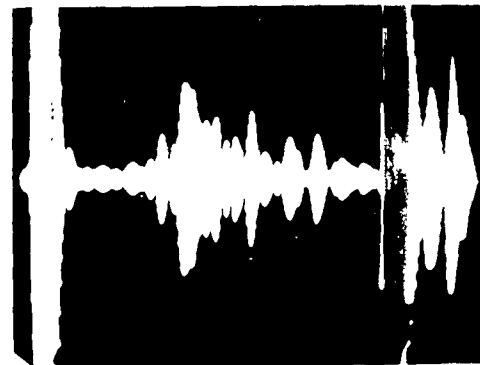
FIGURE 4

STANDOFF GREATER THAN  
INITIATION DISTANCE

Small Pips Show Little  
Internal Damage

STANDOFF LESS THAN  
INITIATION DISTANCE

Larger Pips Indicate  
Heavier Internal Damage

TYPICAL ULTRASONIC REFLECTOGRAMS USED AS  
TESTS FOR INTERNAL DAMAGE

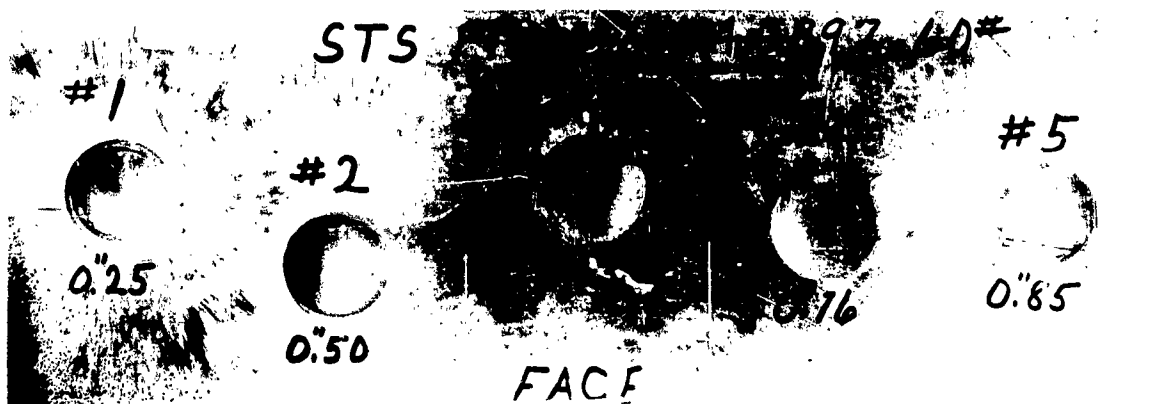
FIGURE 5

FACE OF PLATES SHOWING AREAS OF DIRECT EXPLOSION IMPACT

Data on the individual explosions are listed in Table 1 and the faces of impacted plates are shown in Figure 5. Macrostructures and hardness patterns of sectioned impacts are illustrated in Figures 6, 7 and 8. The shaded part of a hardness pattern extends over the zone where hardness had been increased definitely above that of the base metal. The

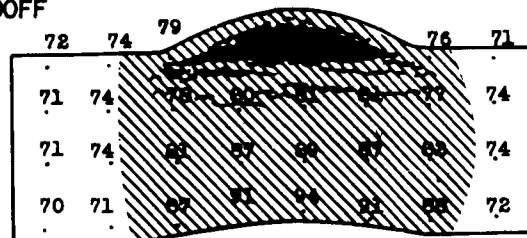
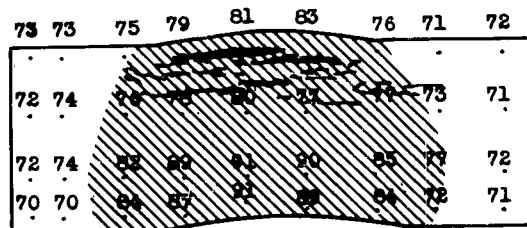
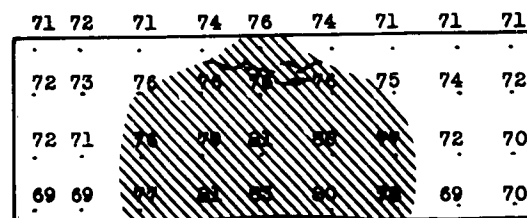
MACROSECTIONS AND HARDNESS DISTRIBUTIONS  
IN DIRECT EXPLOSION TESTS AGAINST 1-1/2"  
THICK PLATE OF MILD STEEL

SHADED AREAS REPRESENT HARDNESS

OF 75 R<sub>B</sub> OR OVER

In the hardness patterns corresponding to first appearance of internal cracks in STS (Figure 7, 0.70 inch standoff) and aluminum alloy (Figure 8, 1.52 inch standoff) the cold-worked zones are separated from the fractures by unworked metal. This is believed to show that the initial fractures resulted from elastic wave action alone and is a confirmation of the reflected wave theory. At lower standoffs where scab fracture existed, the work-hardened zone tended to overlap fractures and it is not certain that scab fracture was caused entirely by elastic reaction. Mild steel in Figure 6 did not show the same relation between work-hardening and fracture because the plastic wave appeared to have traveled much faster in relation to the elastic wave. It will be shown under microstructure that mild steel underwent a special type of plastic deformation from shock known as mechanical twinning. Twinning permits plastic deformation with smaller relative atom movement than slip and therefore it could be expected to proceed at a faster rate than ordinary slip deformation.

Internal fracture changes correlated with decreasing standoff in Figures 6, 7, 8 and 9 revealed that crack initiation occurred at a distance from the back surface greater than the thickness of the scab layer which, at less standoff, lifted and formed a bulge. The relation between these two locations of internal cracking was not clear, apparently they coexisted at low standoff. The contingency must be considered that the dual fracture locations may have been some peculiarity of the method of testing.

Relating tensile data to the steels in Figures 6 and 7, it was noted that both mild steel and STS had about the same thickness of scab layer and depth of initiation fracture notwithstanding the great difference in tensile strength. Aluminum fractures in Figures 8 and 9, however, showed a greater relative depth of both layers although the strength was about that of mild steel.

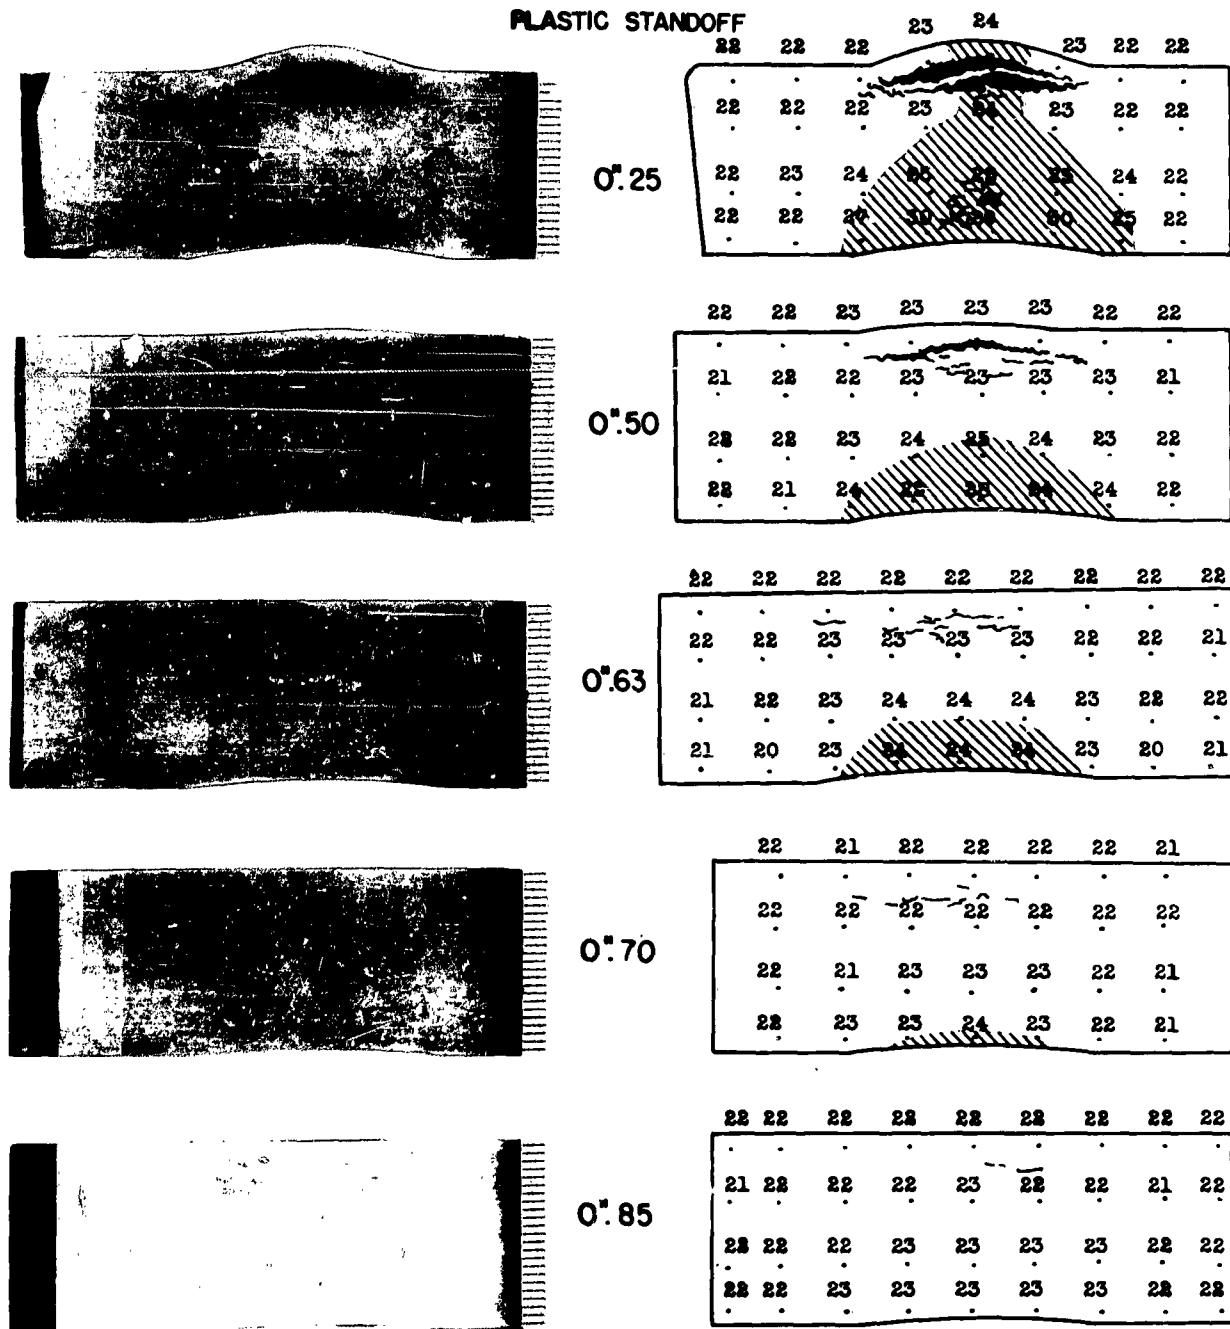
FIGURE 7

MACROSECTIONS AND HARDNESS DISTRIBUTIONS  
IN DIRECT EXPLOSION TESTS AGAINST 1-1/2"  
THICK PLATE OF SPECIAL TREATMENT STEEL

SHADED AREAS REPRESENT HARDNESS  
OF 24 R<sub>C</sub> OR OVER

A section through a simulated squash-head impact on 5-inch Class B armor (similar to STS) was available from another Naval Proving Ground project. It is interesting to note that the scab on the 1-1/2 inch STS plate of Figure 7 and the scab on the 5-inch plate shown in Figure 16 both have similar characteristics.

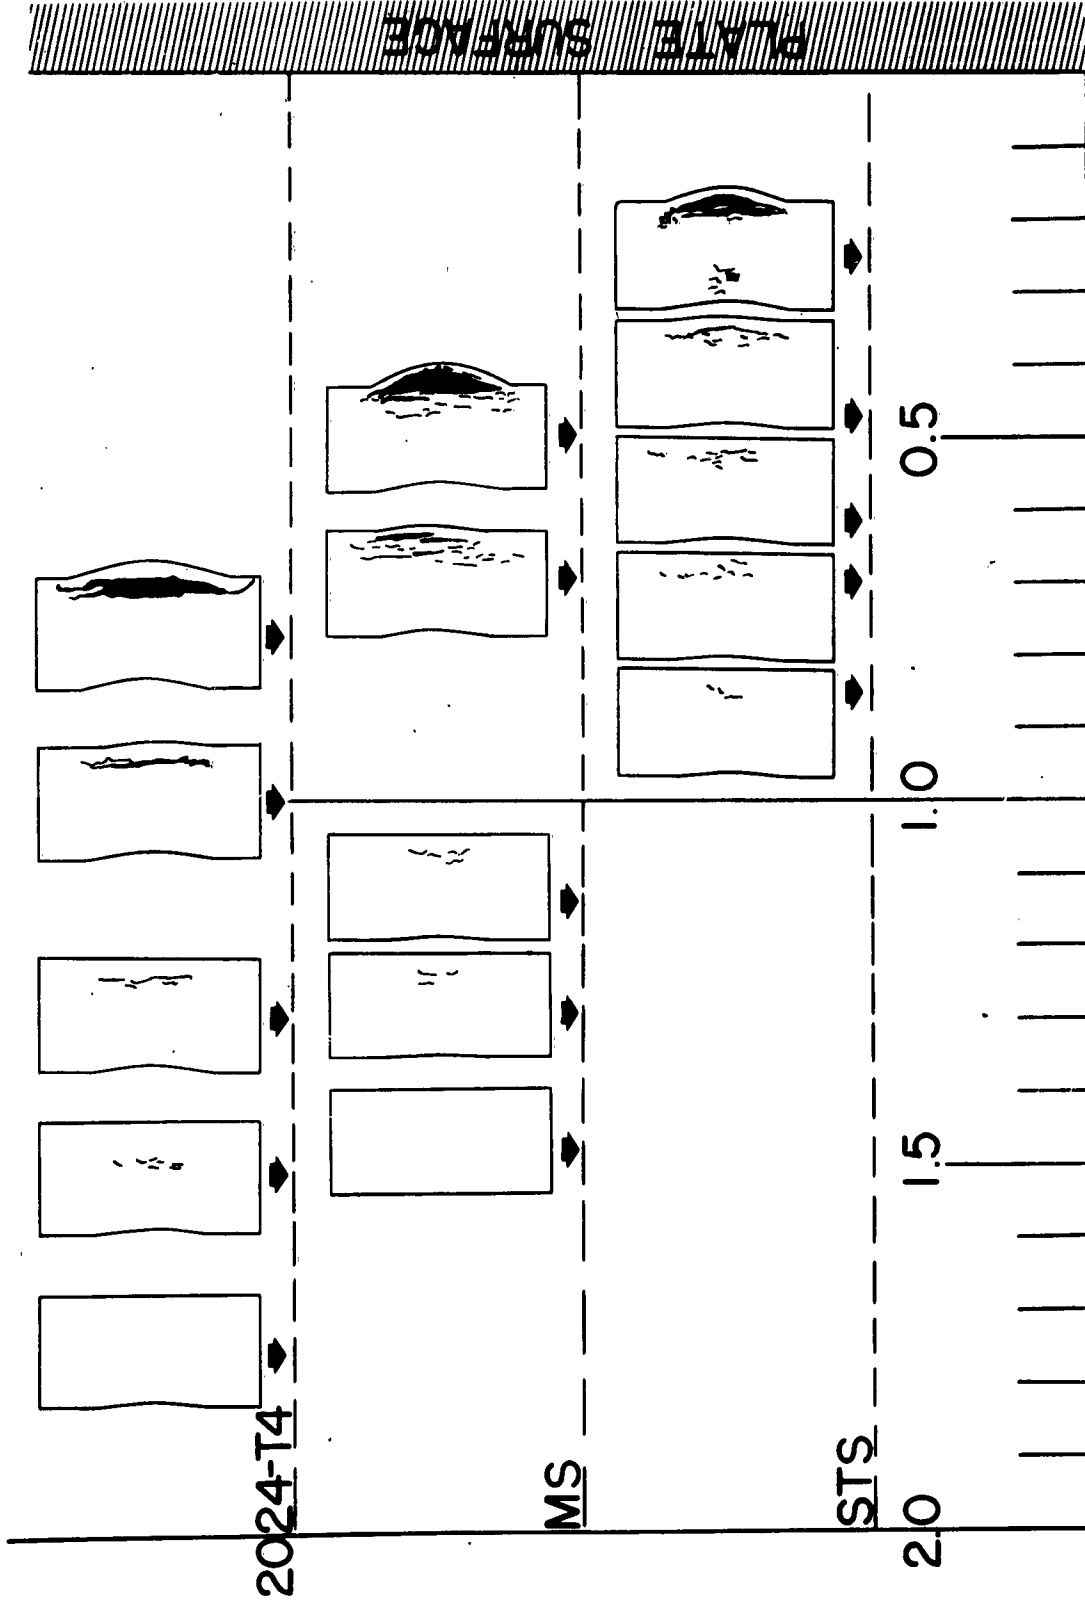
FIGURE 10

COMPARATIVE SKETCHES OF DAMAGE RESULTING FROM DIRECT EXPLOSION  
TESTS AGAINST 2024-T4 ALUMINUM, MILD STEEL AND STS ARMOR  
CONFIDENTIAL

Input of shock energy should be some function of standoff distance; therefore, a general comparison was made of all three plates on the basis of standoff in Figure 10. It was evident that STS had greater resistance to internal fracture than the same thickness of mild steel or aluminum alloy. Comparing only the latter two, mild steel showed a slight superiority on a basis of equal thickness. This investigation is being continued to determine the relative performance of these materials at the same weight per square foot.

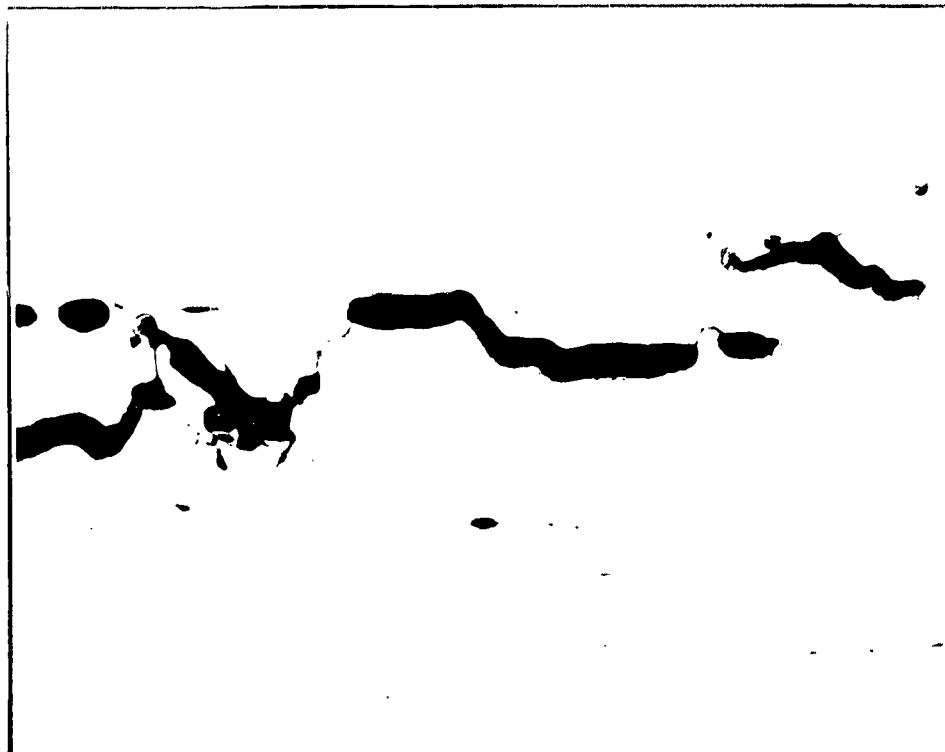
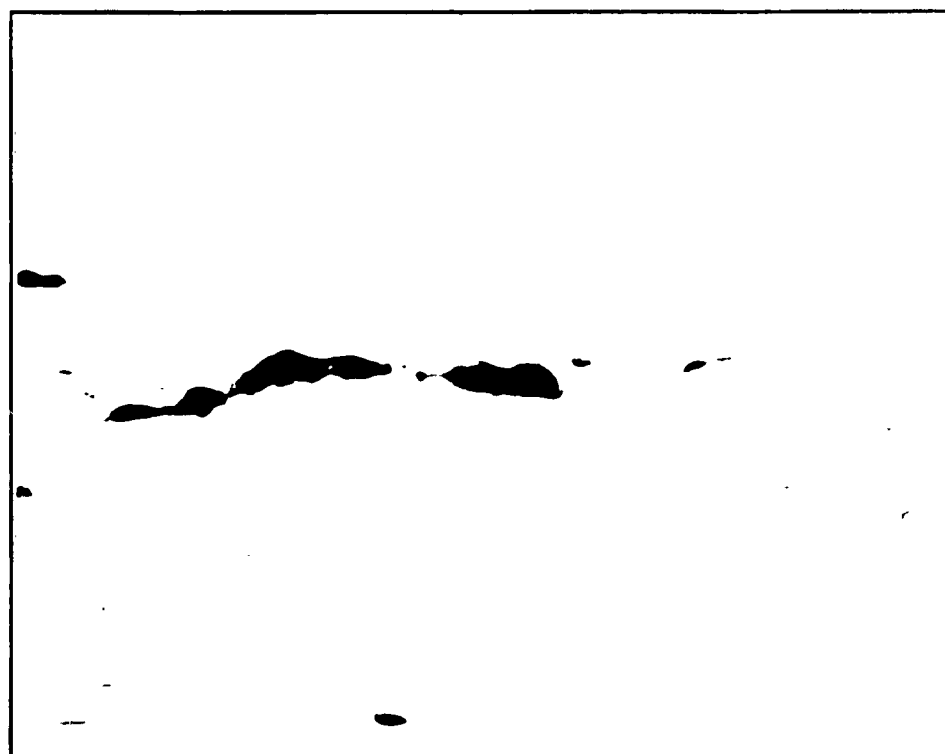
FIGURE 12

INITIATION FRACTURES IN MILD STEEL  
UNETCHED, X200

Impacts which gave initiation fractures only were examined and the photomicrographs are shown in Figures 12 and 13. The typical fracture was composed of flat steps or breaks parallel to the plate surface and joined together by irregular shear fractures.

Inclusions, if associated at all with direct explosion fracture, must have been only such that chanced to be directly in the fracture path. Adjacent inclusions in the highly stressed fracture zone showed practically no evidence of separation, Figure 12 and Figure 13(B). The STS, Figure 13(A), was found to be an exceptionally clean steel almost free from inclusions.

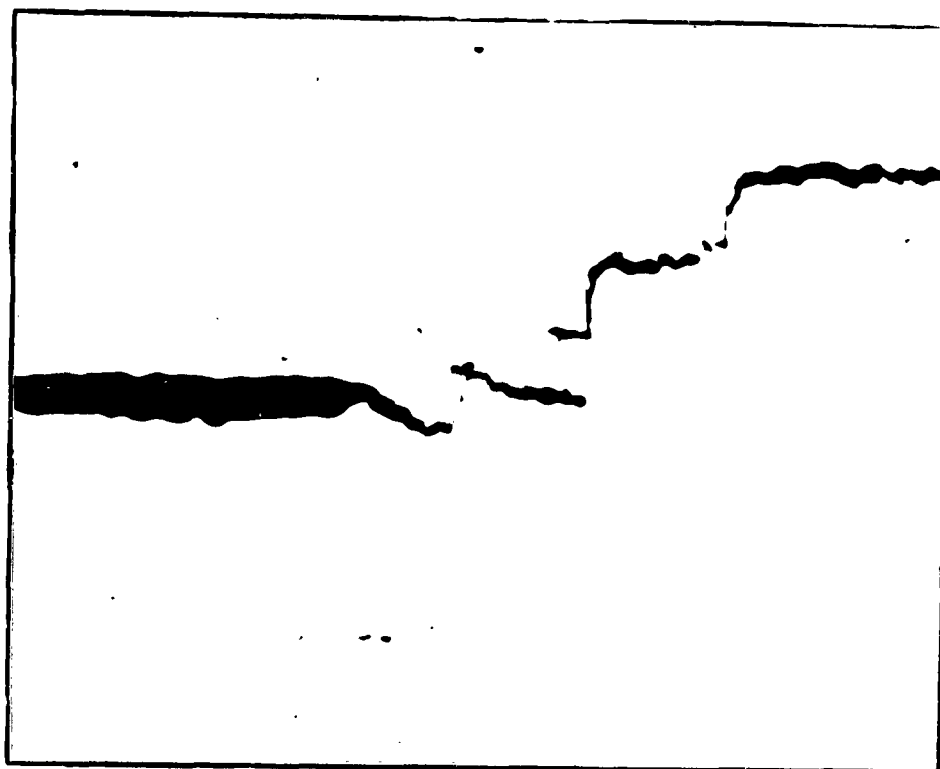
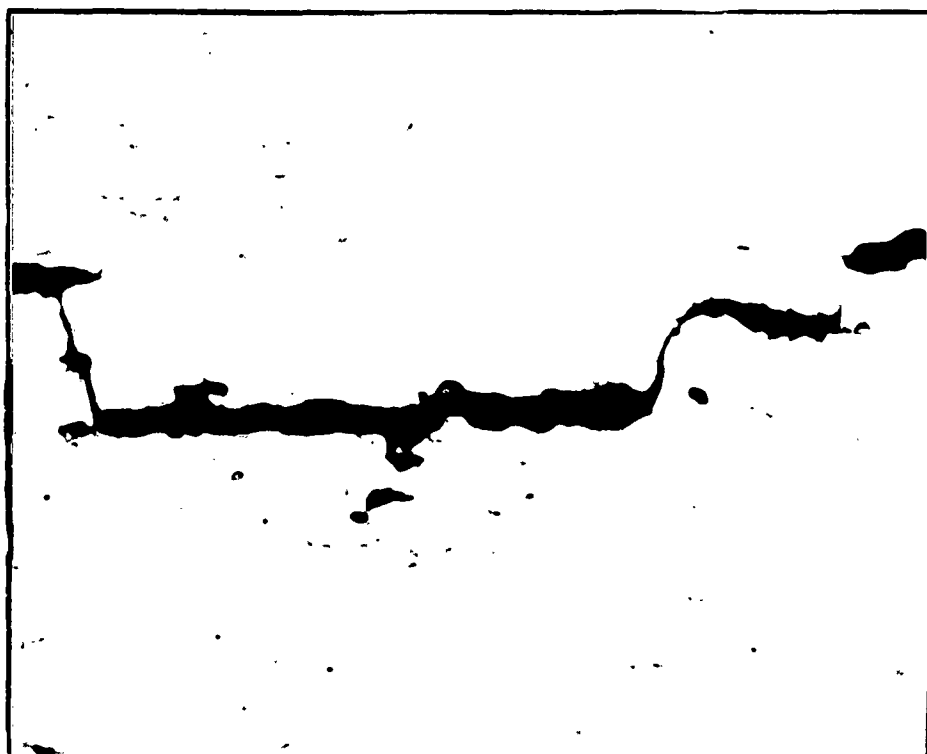
(A) STS ARMOR

(B) 2024-T4 ALUMINUM ALLOY

TYPICAL INITIATION FRACTURES  
UNETCHED, X200

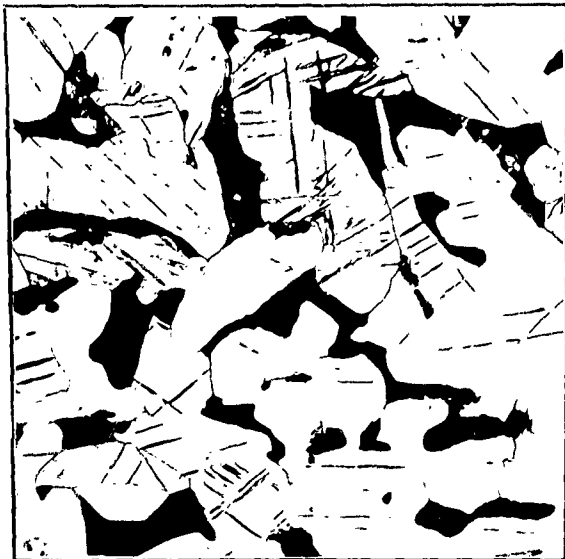
FIGURE 14

(A) DIRECTLY UNDER  
IMPACT AT FACE

(B) 3/8 INCH BEHIND  
FACE

(C) 3/4 INCH BEHIND  
FACE

(D) 1-1/2 INCH BEHIND  
FACE, BACK OF PLATE

MILD STEEL MICROSTRUCTURES SHOWING DIMINISHED  
MECHANICAL TWINNING WITH INCREASED DISTANCE  
FROM IMPACTED FACE OF PLATE, 1"28 STANDOFF  
NITAL-PICRAL ETCH, X200

The etched microstructures in Figures 14 and 15 depict explosive impact effects on metal grain structure. The well-known mechanical twins or Neumann bands associated with shock deformation of ferrite were present in the mild steel (Figure 14). It has been mentioned that shock twinning may explain a unique property of high plastic wave velocity in mild steel deduced from the hardness patterns of sectioned impacts. The STS plate (Figure 15(A)) had a quenched and tempered structure with no evidence of shock twinning even in minute ferrite grains near the impact face. The grain structure of the aluminum alloy in Figure 15(B) likewise gave no visible evidence of special effects from shock deformation.

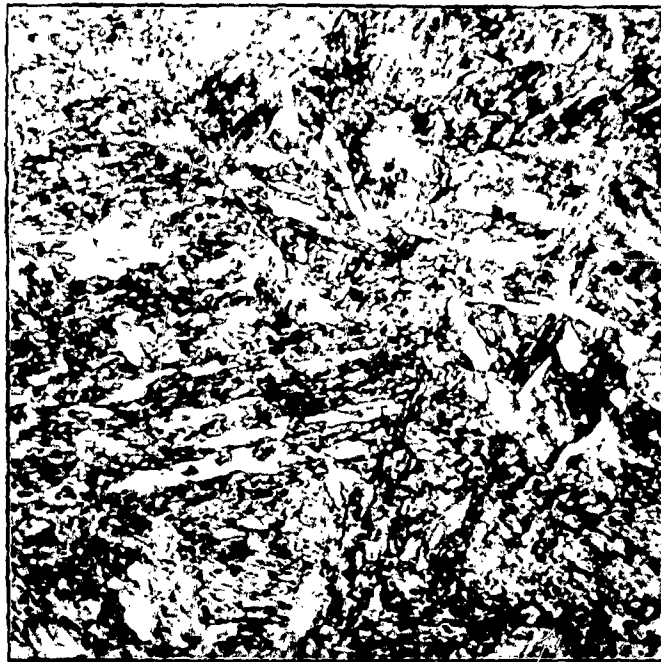
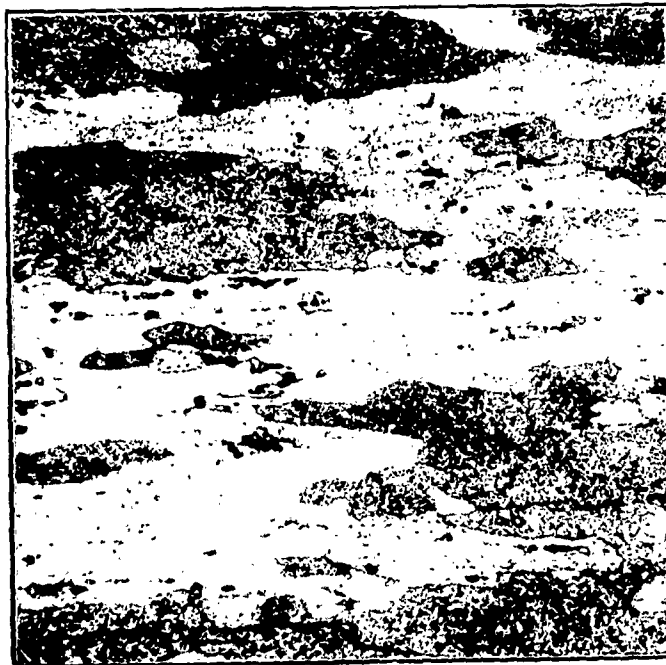
(A) STS ARMOR, 0.76 STANDOFF  
NITAL-PICRAL ETCH, X1000

(B) 2024-T4 ALUMINUM ALLOY,  
1.52 STANDOFF  
KELLER'S ETCH, X250

MICROSTRUCTURE AT IMPACT FACE
